Building Number: 9

Original Name: Administration / Dormitory

Est. Year of Construction: 1951

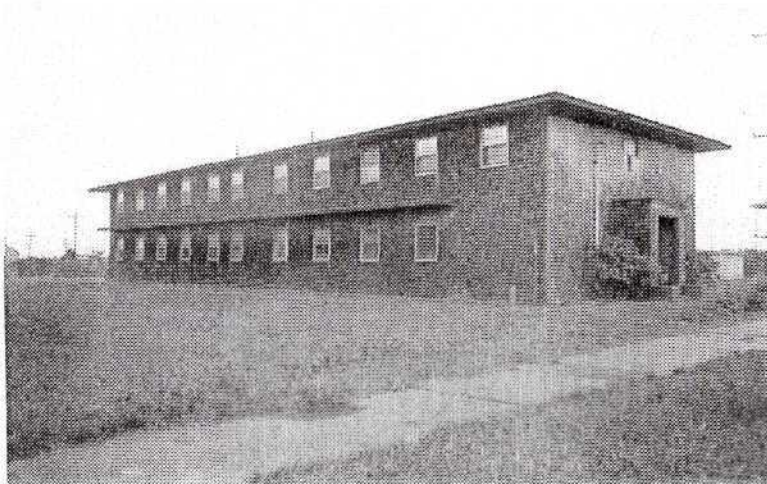
View from northeast.

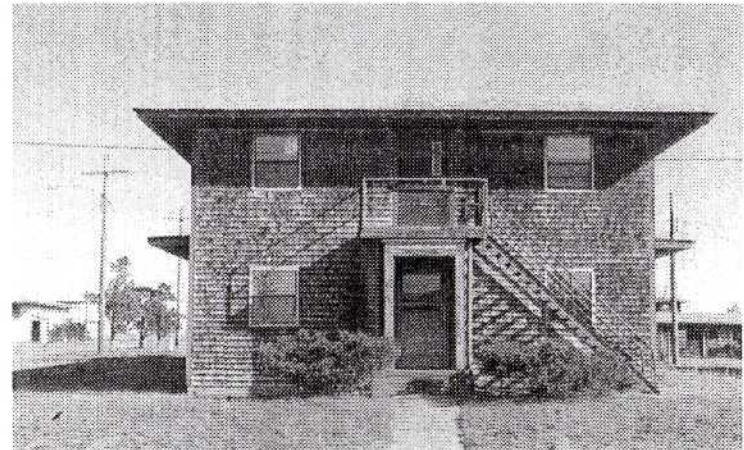
West facade.

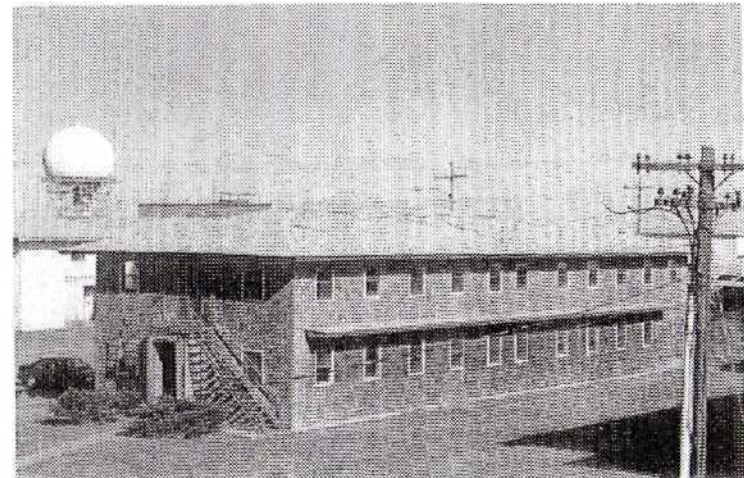
View from southeast.

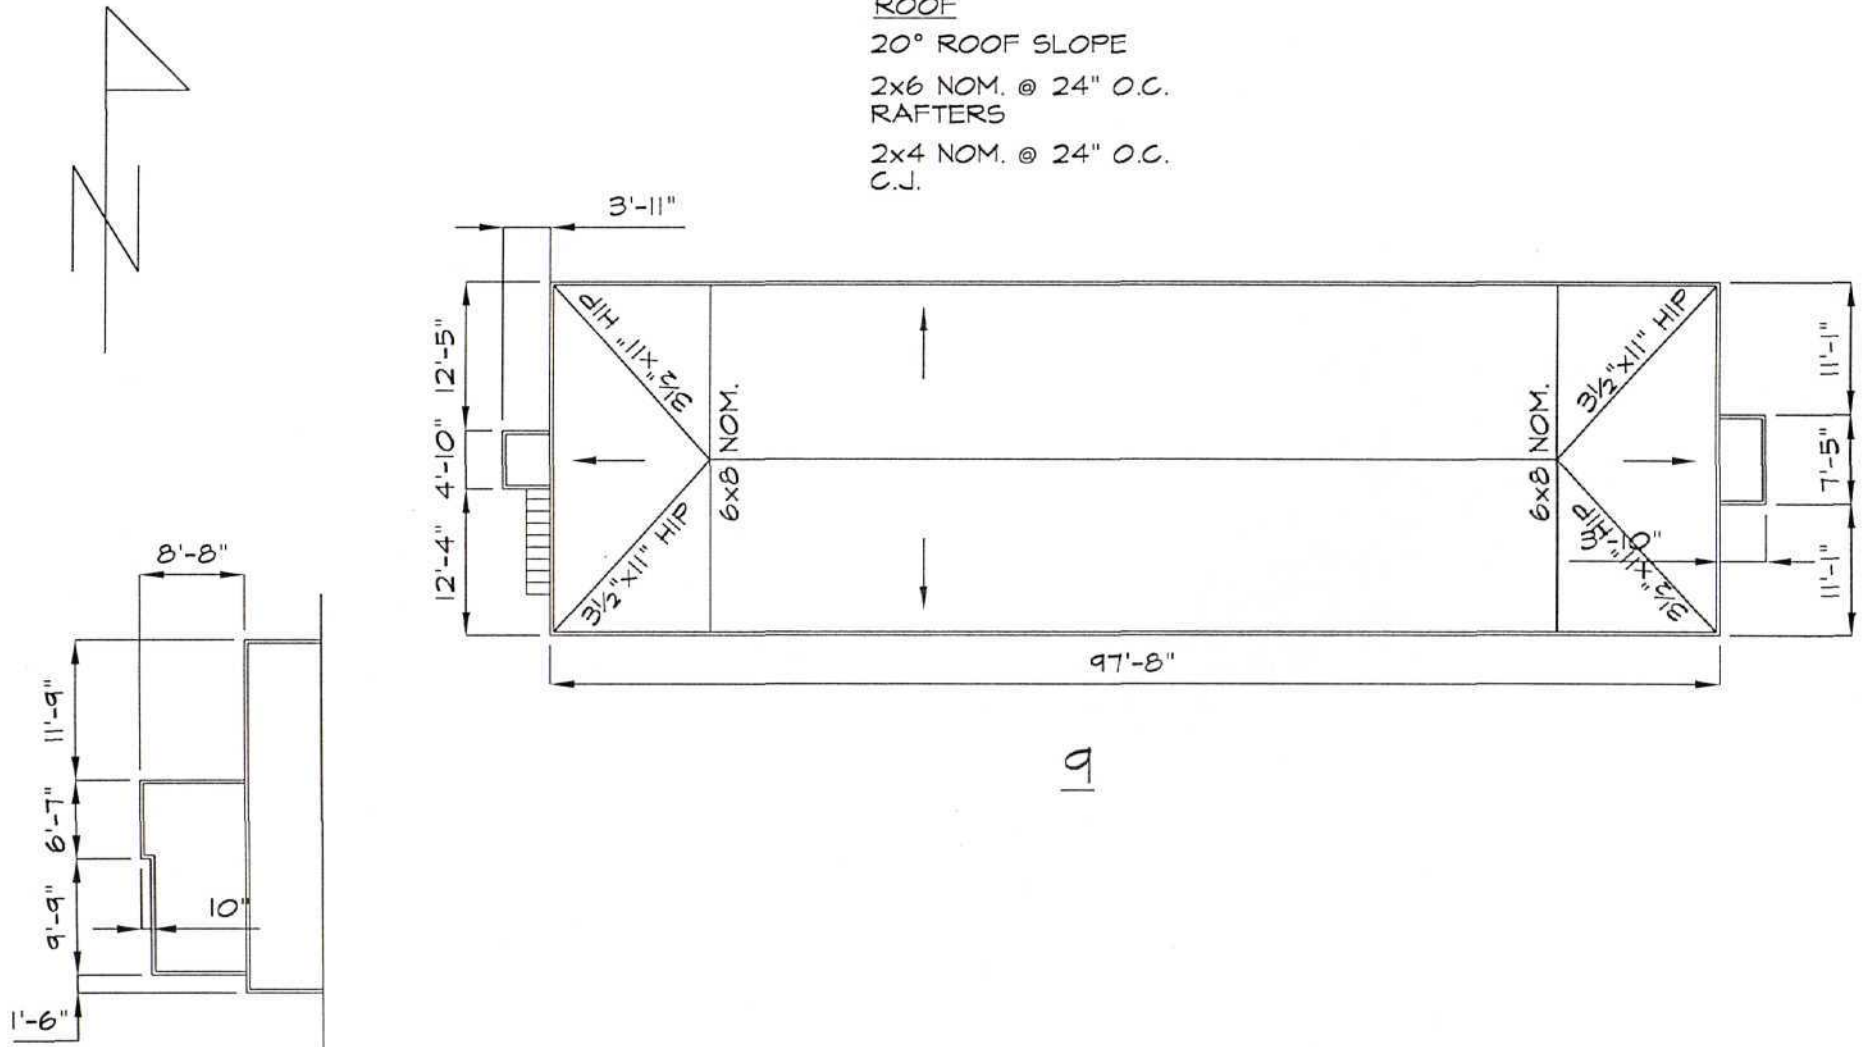
20° ROOF SLOPE

2x6 NOM. @ 24" O.C.
RAFTERS

2x4 NOM. @ 24" O.C.
C.J.
